# New or secondhand?

### Lagrado: a Lagoon 400, always a sure bet!

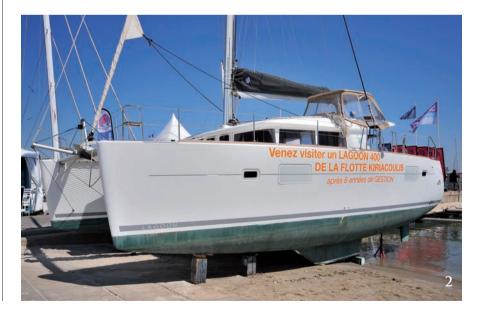
1 - A compact and easy-to-live-with catamaran, both at sea and at anchor. \$2 - A catamaran that works and keeps in shape!

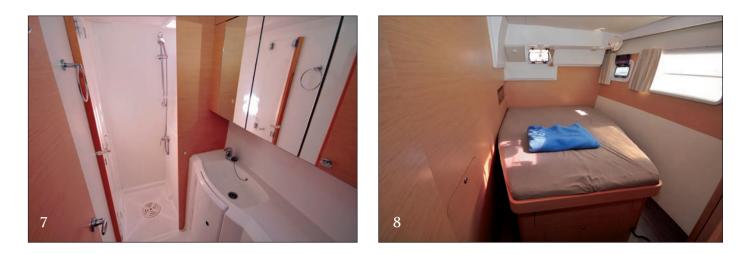
5 - THE SALOON AS SEEN IN APRIL 2017: ALL THE JOINERY AND TRIM IN ALPI LIGHT OAK HAVE STOOD UP WELL TO (PROBA-BLY CAUTIOUS) USE. THE GALLEY EQUIPMENT (OVEN, GAS COOKER, FAUCETS, DRAWERS) ARE IN VERY GOOD CONDITION, AS ARE THE FLOORS, CURTAINS AND HEADLININGS.

6 - THE CABINS ARE VERY CLOSE TO THEIR ORIGINAL CONDITION
